Manhole Inspection Summary

Manhole # S69M__009MH

Insp Date: 1/31/08 10:53 AM

Location Address: **6517 O'Donnell St.**

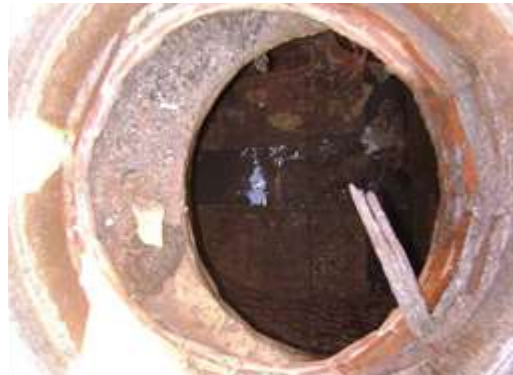
Top View

Comments **FIELD CREWS VERIFIED THAT S69M__009MH DOES NOT CONNECT TO S69M__028MH. THE 3 O'CLOCK PIPE ON S69M__009MH IS ABANDONED AND DOES NOT CONNECT AS THE MAP INDICATES. HEAVY DEBRIS IN CHANNEL OF INCOMING 9 O'CLOCK.**
